# UNDERWATER BRIDGE INSPECTION REPORT

STRUCTURE NO. 3575

FORD PARKWAY

MISSISSIPPI RIVER

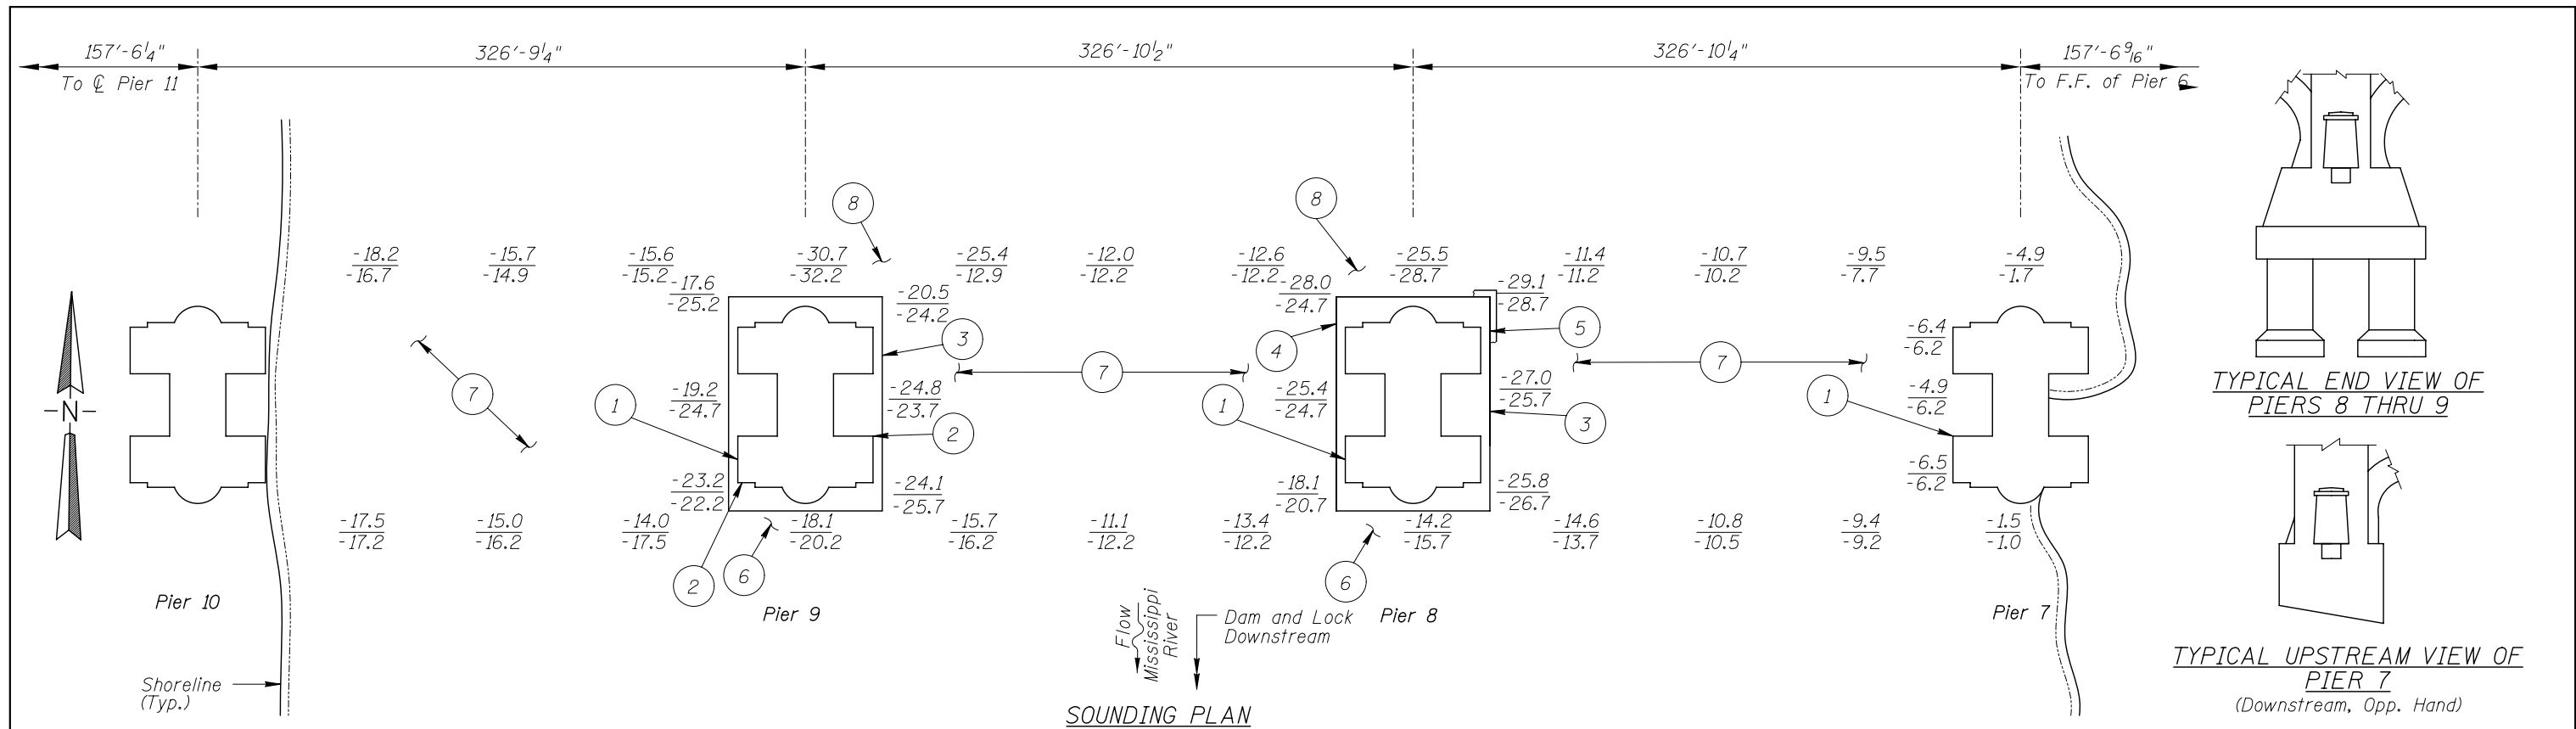
UPSTREAM FASCIA PROFILE

- (B) The footing was exposed around the entire perimeter of Piers 8 and 9. Typically, the exposed portions of the footing exhibited heavy scaling with 1 to 2 feet of penetration related to section loss.

- (D) Localized scour depressions were observed around the upstream end of Piers 8 and 9 with typical depths of 5 to 10 feet. Concrete rubble with protruding reinforcing bars was found at the base of the scour depressions, as well as around much of the piers, appearing to have found its way there as the result of recent concrete rehab at the bridge.

- (A) Monitor footing exposures at Piers 8 and 9 and undermining at Pier 8 during future underwater inspections for further vertical face exposure and/or undermining.
- (B) Reinspect the submerged substructure units at the normal maximum recommended (NBIS) interval of five (5) years.
